Global Heritage Network

Satellite Imagery Briefing: Monitoring Endangered Cultural Heritage Sites

Early Warning and Threat Monitoring System for Cultural Heritage Sites in the Developing World

Endangered Global Heritage Sites: 2011 Examples

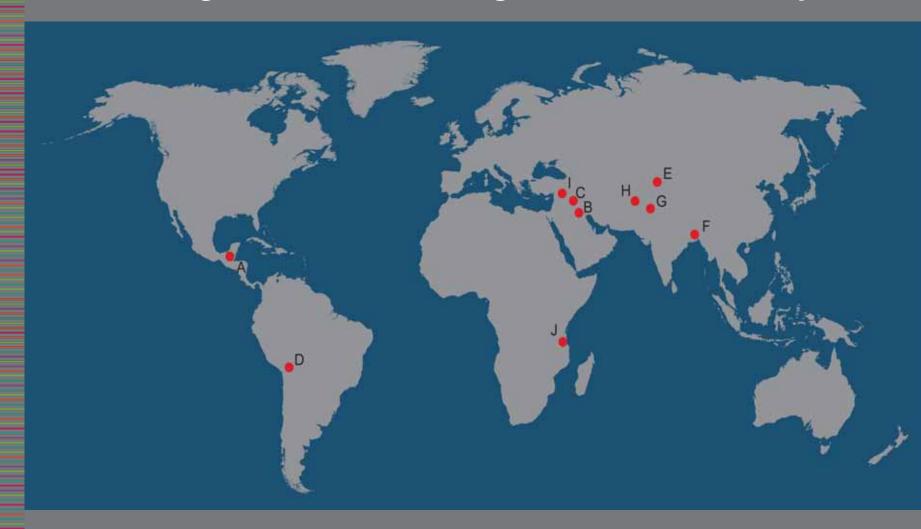
- A. Mirador, Guatemala Development Pressures
- B. Umma (Tell Jokha), Iraq Looting
- C. Nineveh, Iraq Development Pressures
- **D. Tiwanaku**, **Bolivia** Inauthentic Restoration
- E. Kashgar Old Town, China Development Pressures
- **F. Mahansthangarh**, **Bangladesh** Development Pressures
- G. Jahangir, Pakistan Neglect and Insufficient Management
- H. Mes Aynak, Afghanistan Development Pressures
- I. Carchemish, Turkey / Syria Development Pressures
- J. Kilwa Kisiwani, Tanzania Natural Threats

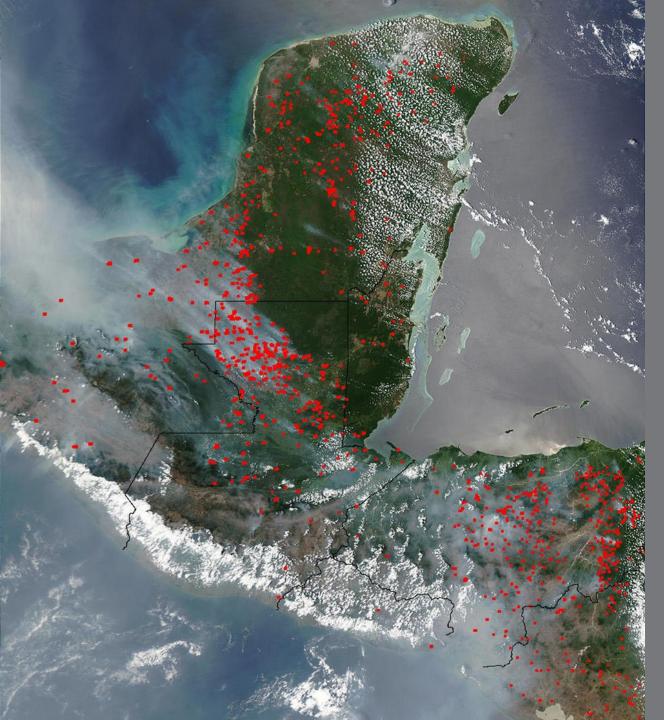
Mirador, Guatemala – Development Pressures

As seen in this satellite image, destructive fires are a major threat to the Mirador Basin. Drug trafficking profits are fueling a massive ranching industry which requires large areas of jungle to be cleared and has virtually destroyed the Maya Biosphere (Natural & Cultural Heritage) within the past five years in northern Guatemala.

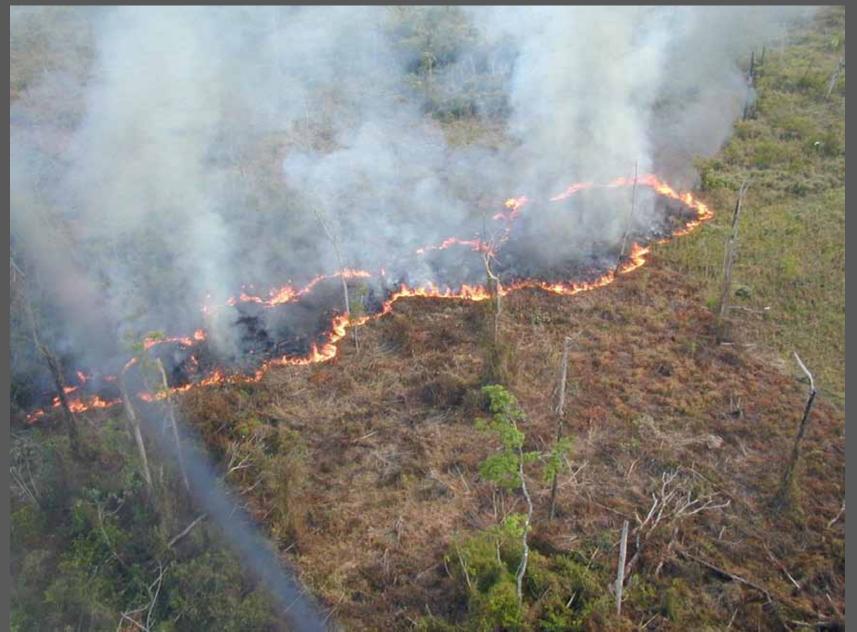
Mirador, Guatemala – Development Pressures

Below, a helicopter view of a forest frontier being burned via the technique of slash and burn agriculture.

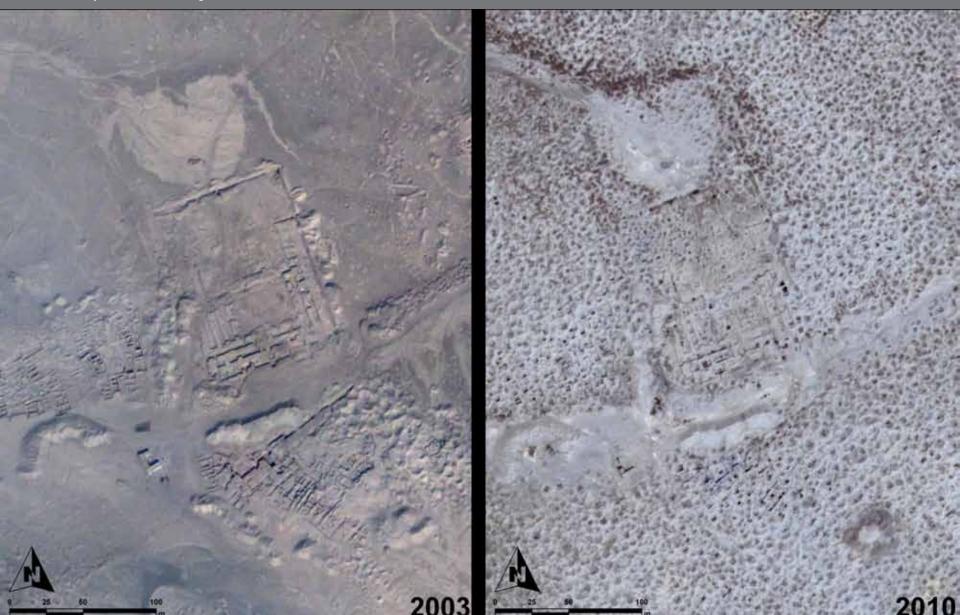
Umma (Tell Jokha), Iraq – Looting

High-resolution DigitalGlobe satellite imagery from February 2003 of the ancient archaeological site of Umma, before the Iraq War started (at left). Only scattered looting is evident. The same view from 2010 (at right), devastated by massive looting.

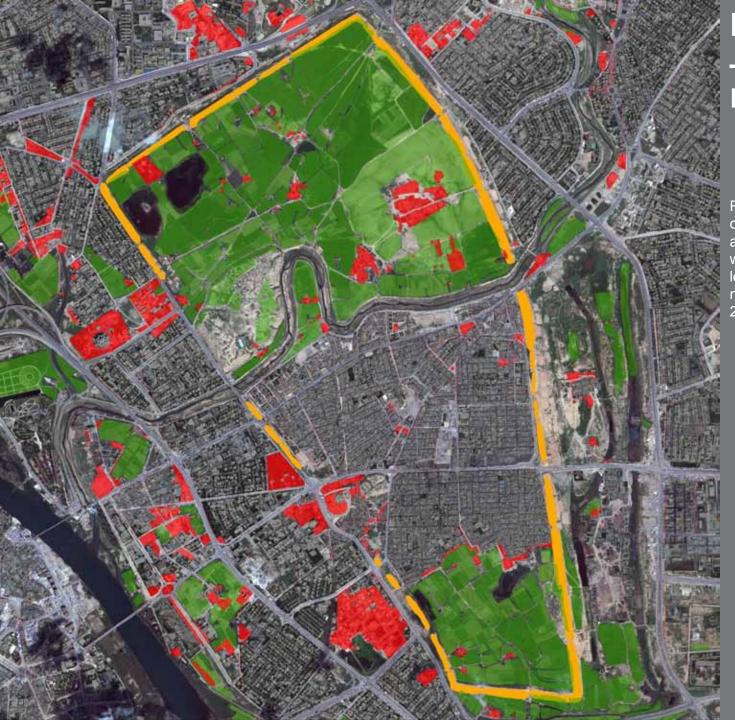
Nineveh, Iraq – Development Pressures

Residential development has covered a huge swath of the ancient city of Nineveh, whose walls are visible in orange to the left. Red polygons are areas of new urban development between 2005 and 2010.

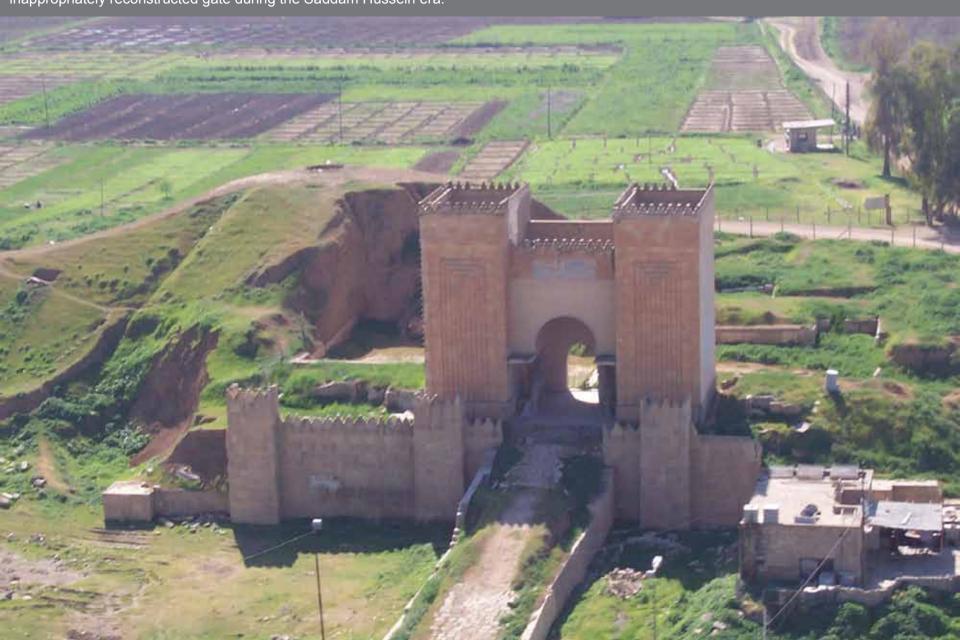
Nineveh, Iraq – Development Pressures

Cultivation occurs on over 60% of the land inside the ancient walls of Nineveh. Below, an inappropriately reconstructed gate during the Saddam Hussein era.

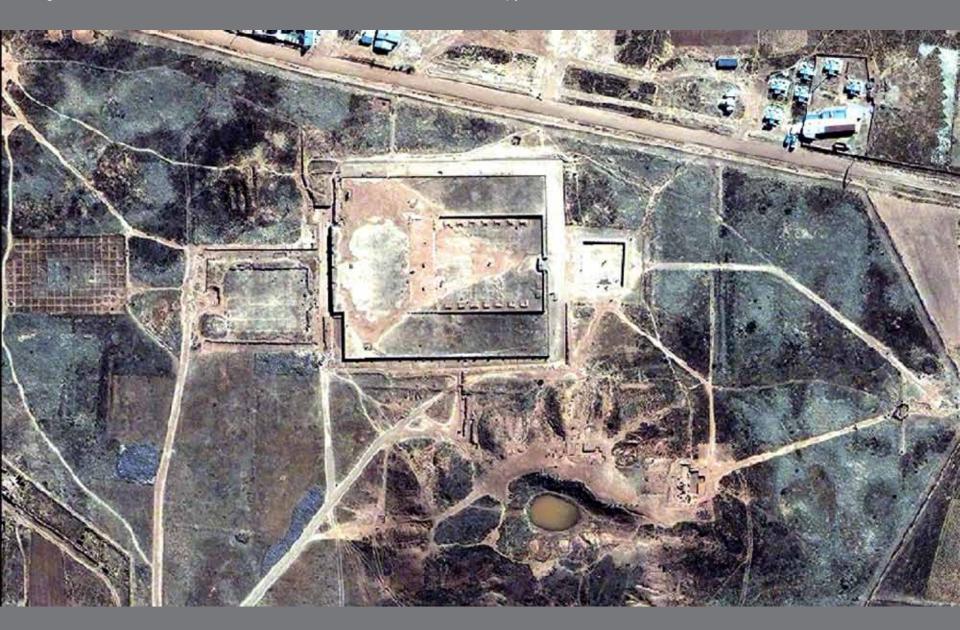
Tiwanaku, Bolivia - Inappropriate Restoration

Inauthentic restoration techniques have threatened the World Heritage status of this significant heritage site. Below, the site in 2003 **BEFORE** the reconstruction of ancient pyramid walls.

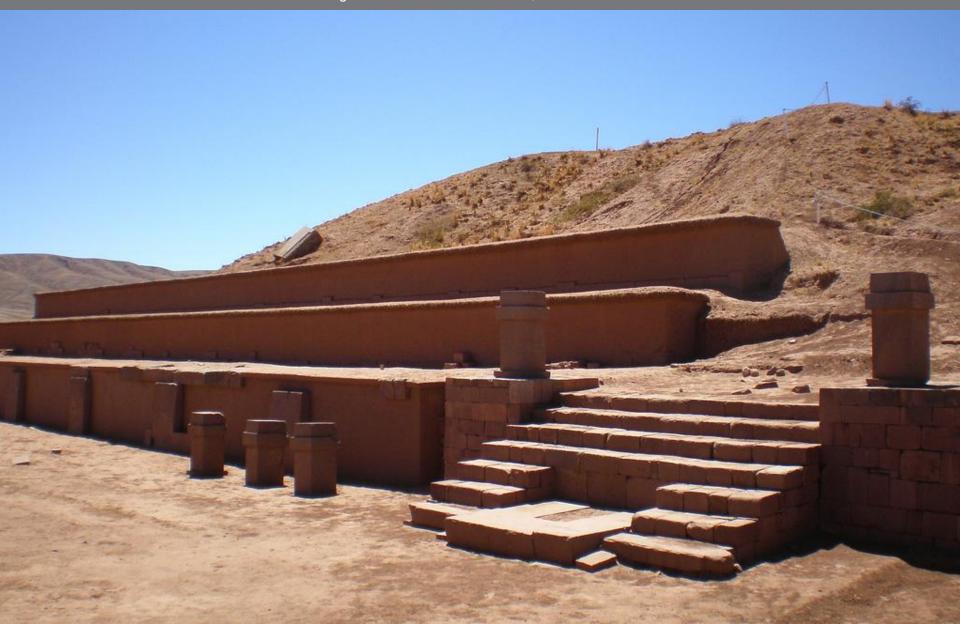
Tiwanaku, Bolivia - Inappropriate Restoration

Below, the reconstructed walls. The Bolivian government was responsible for the reconstruction, and UNESCO has threatened to remove Tiwanaku's World Heritage status as a result. To date, this has not occurred.

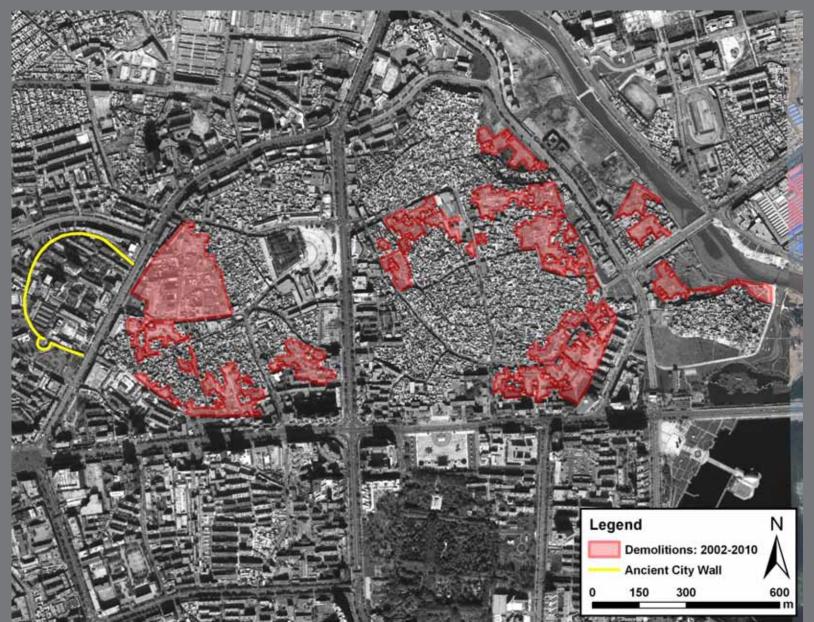
Kashgar Old Town, China – Development Pressures

As viewed in this high-resolution DigitalGlobe image from October 2010, significant portions of the old town of Kashgar have been demolished to make way for modern development.

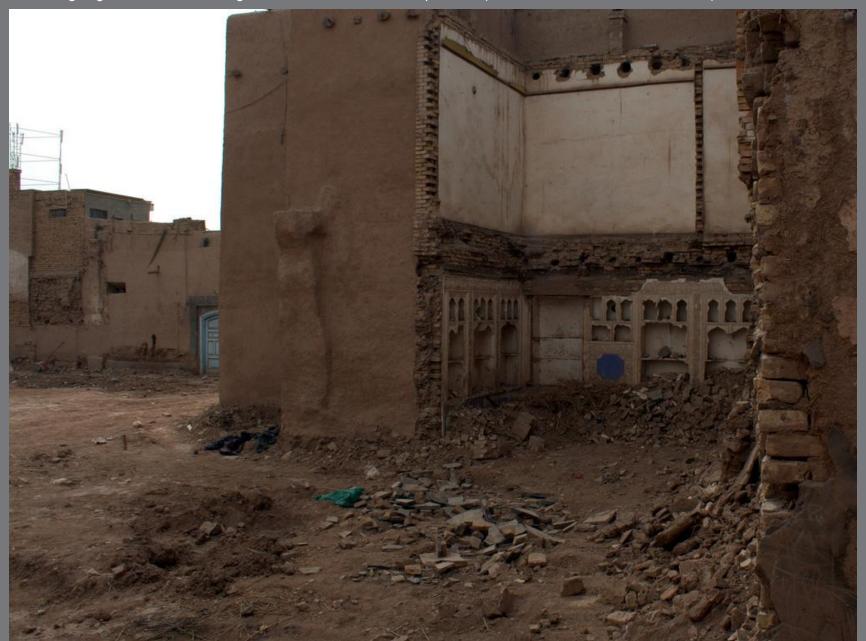
Kashgar Old Town, China – Development Pressures

The dramatic ongoing demolitions of Kashgar's Old Town, seen close up below. (Preston Rhea, Creative Commons)

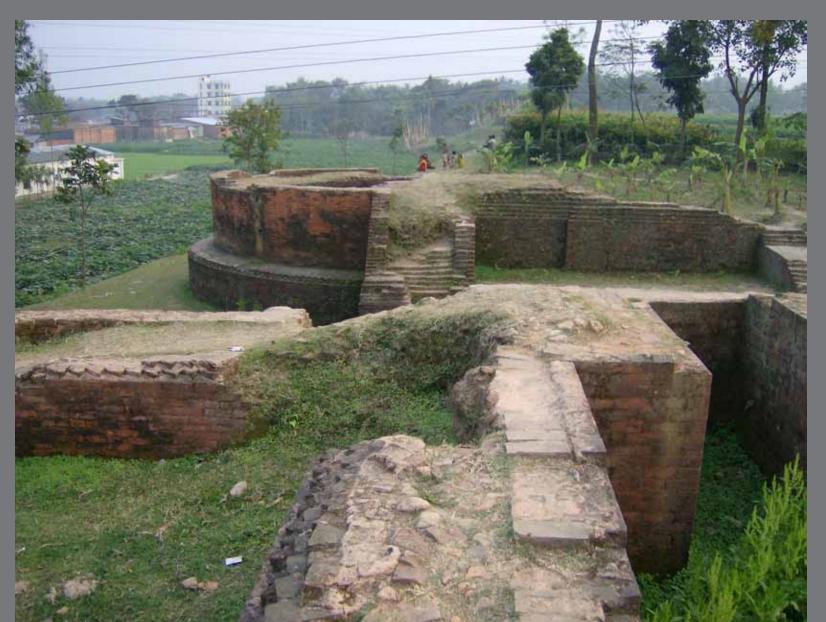
Mahansthangarh, Bangladesh – Development Pressures

A clear example of ancient city walls being used for agricultural purposes (here, banana cultivation). The site lacks sufficient management to prevent damaging practices such as these.

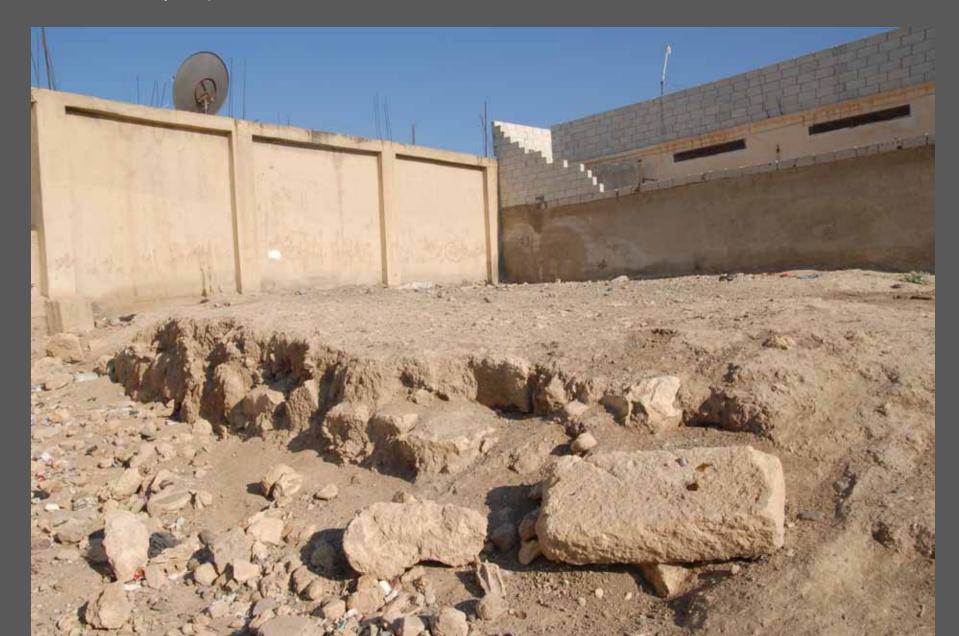
Carchemish, Turkey / Syria – Development Pressures

The urban encroachment on this site is starkly portrayed in the image below. New homes have been constructed directly on top of the ancient settlement.

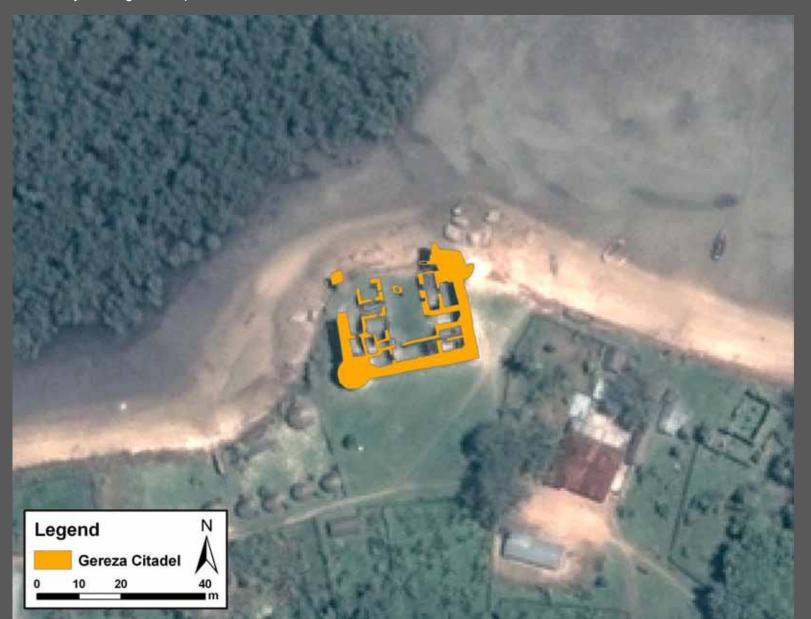
Kilwa Kisiwani, Tanzania – Natural Threats

The ancient fortress of Gereza, one of the main structures of the archaeological site of Kilwa Kisiwani, is at risk of collapsing into the Indian Ocean should projected rises in sea levels occur. It is currently threatened by the negative impacts of erosion.

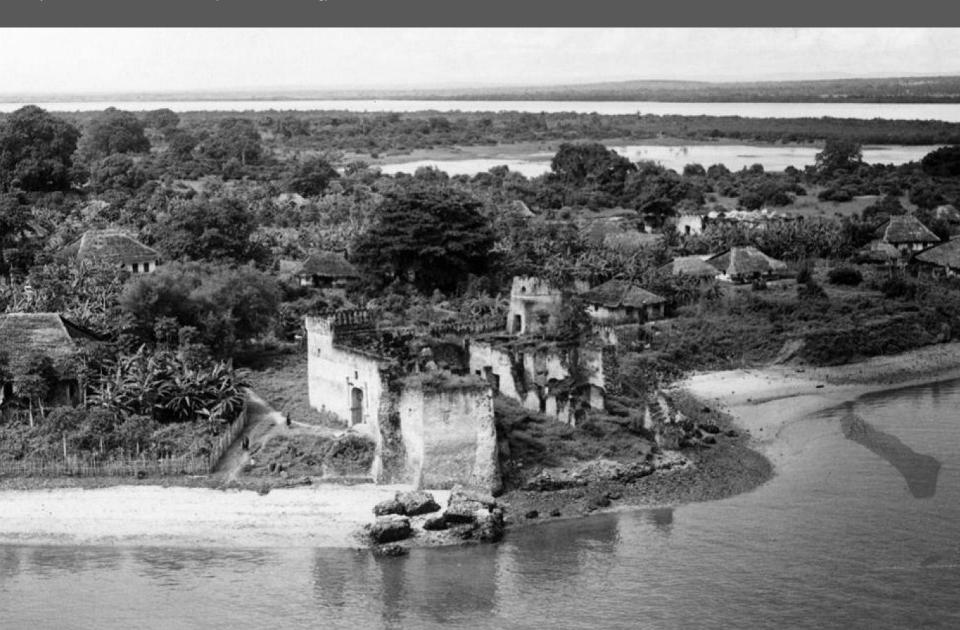
Kilwa Kisiwani, Tanzania – Natural Threats

An historical aerial view of the Gereza fortress, which has had nearly one third of its original structure collapse into the Indian Ocean. (*Photo: aluka.org*)
