Site Map - Natural Significance & Threats

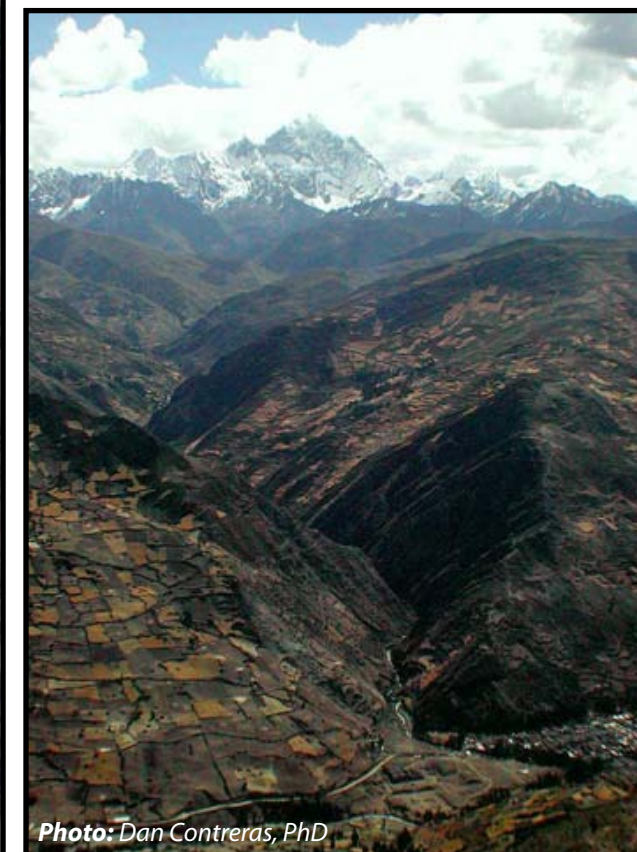
Core Archaeological Zones
-

Mosna River
-

Modern Road
