Wat Phu, Laos

Sacred Temple Complex of Khmer Kings

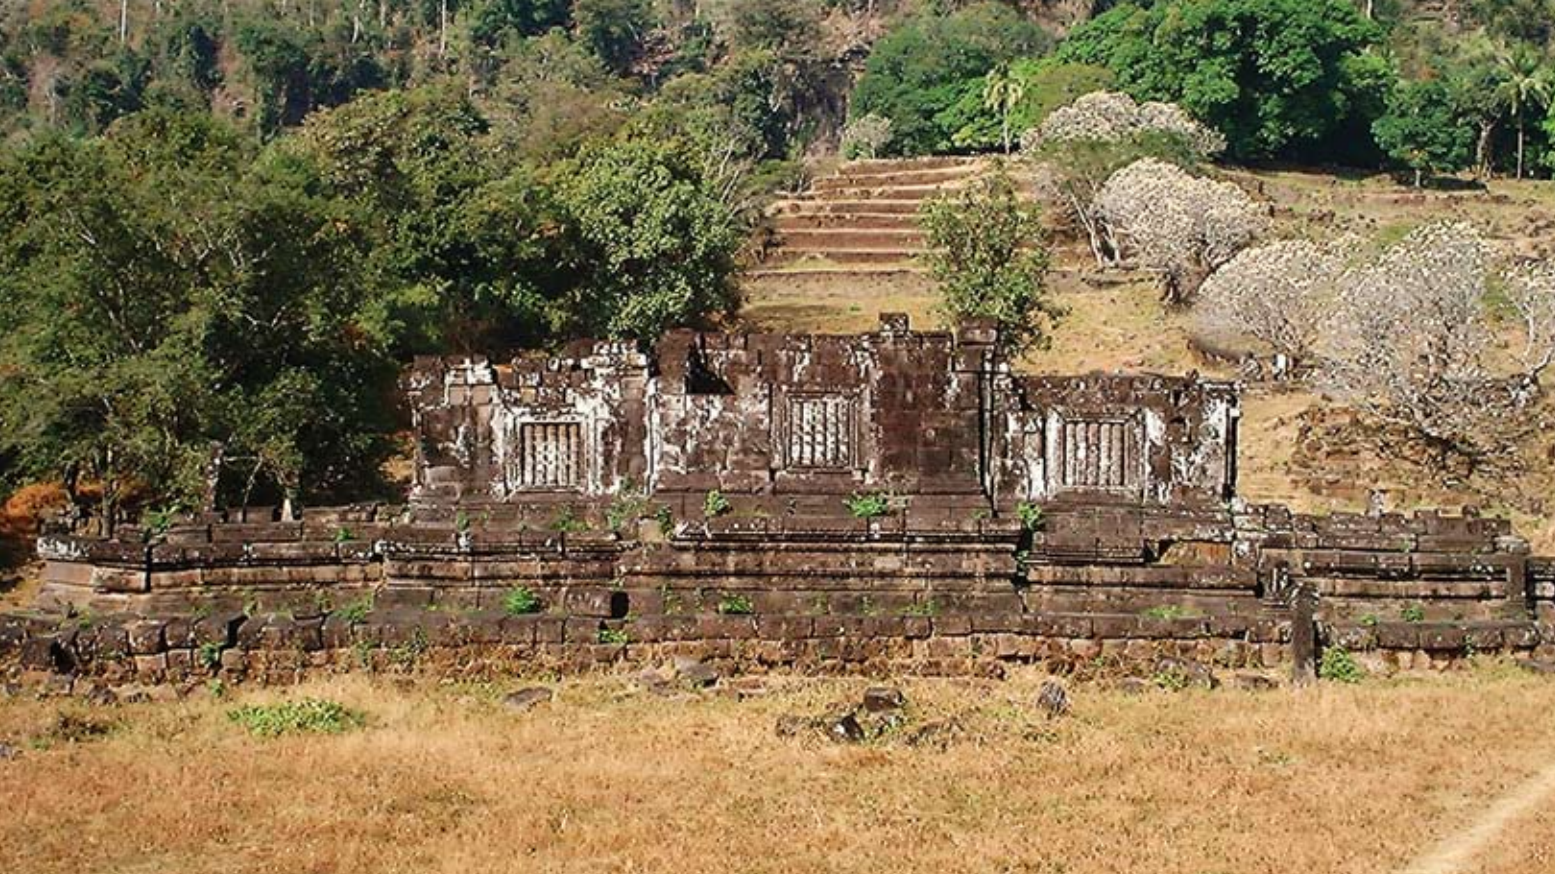
Nandin Hall dates back to the mid-11th century AD. Photo by © Global Heritage Fund

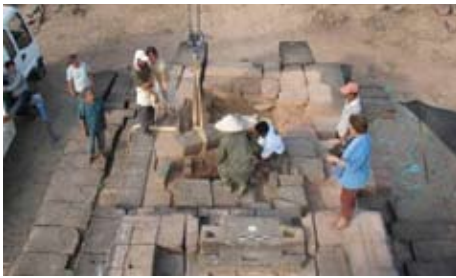
Restoration and stabilization efforts on Nandin Hall.
Photo by © Leric Institute

Conservation efforts at Wat Phu are concentrated on Nandin Hall, one of the most significant architectural remains in the park. Due to settling and uncontrolled vegetation growth, the structure has been weakened and faces collapse, so a program of stabilization

and anastylosis is underway. This will employ the original building materials recovered at the site or newly quarried stones from the same quarries exploited in ancient times during the original construction.

- Concerted anastylosis of Nandin Hall: partial dismantling, consolidation and restoration.
- Installation of drainage system under Nandin Hall porch floor.
- Installation of a temporary roof over Nandin Hall to minimize damage during rainy season.
- Repairing a number of the original laterite construction blocks with appropriate materials.
- Quarrying a number of new laterite blocks to replace those missing.
- Creation of a new mortar based on chemical analyses of original mortar used.

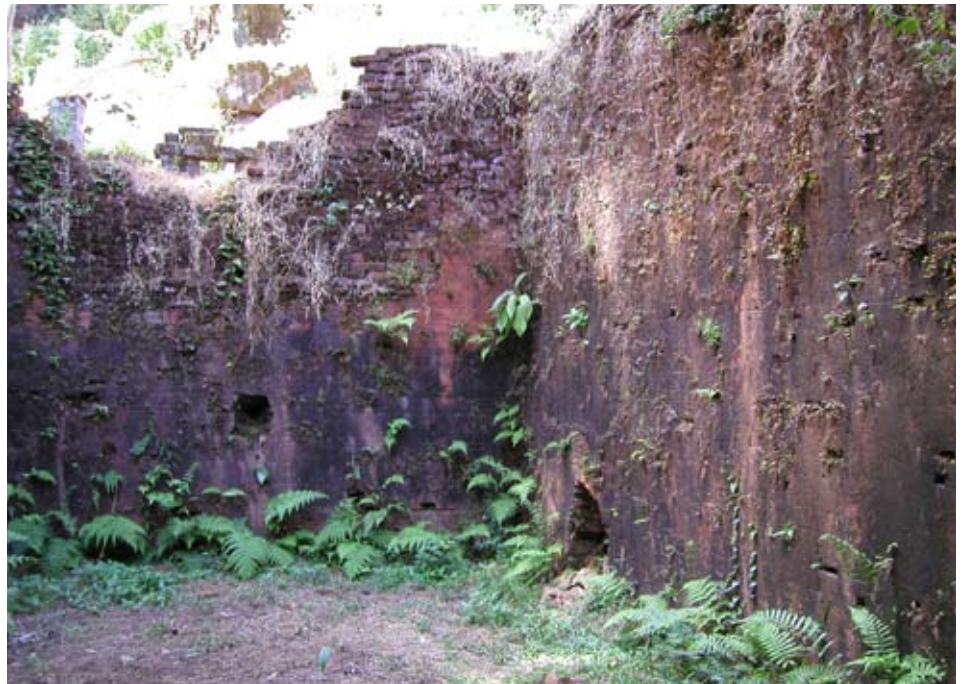
Vegetation overgrowth, one of the threats affecting various structures in the Sacred Temple Complex of Wat Phu, Laos.
Photo by © Global Heritage Fund
